## Skokie Consolidated Drainage District IEPA MS4 Inspection Summary Report – Permit Year 23

Inspection Period: March 2025 – March 2026

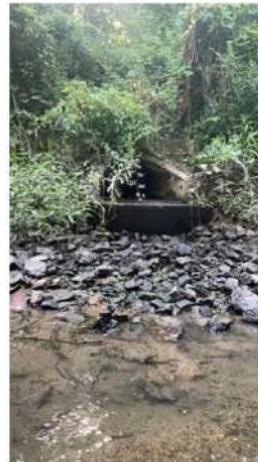
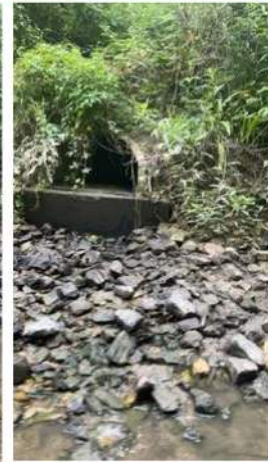
Figure 2 Sample Outfall Report

| Section C – Physical Indicators | |
|---|---|
| Outfall Damage: None | Comment: |
| Deposits/Stains: Flow Line | Comment: |
| Do physical indicators suggest an illicit discharge is present? No | |

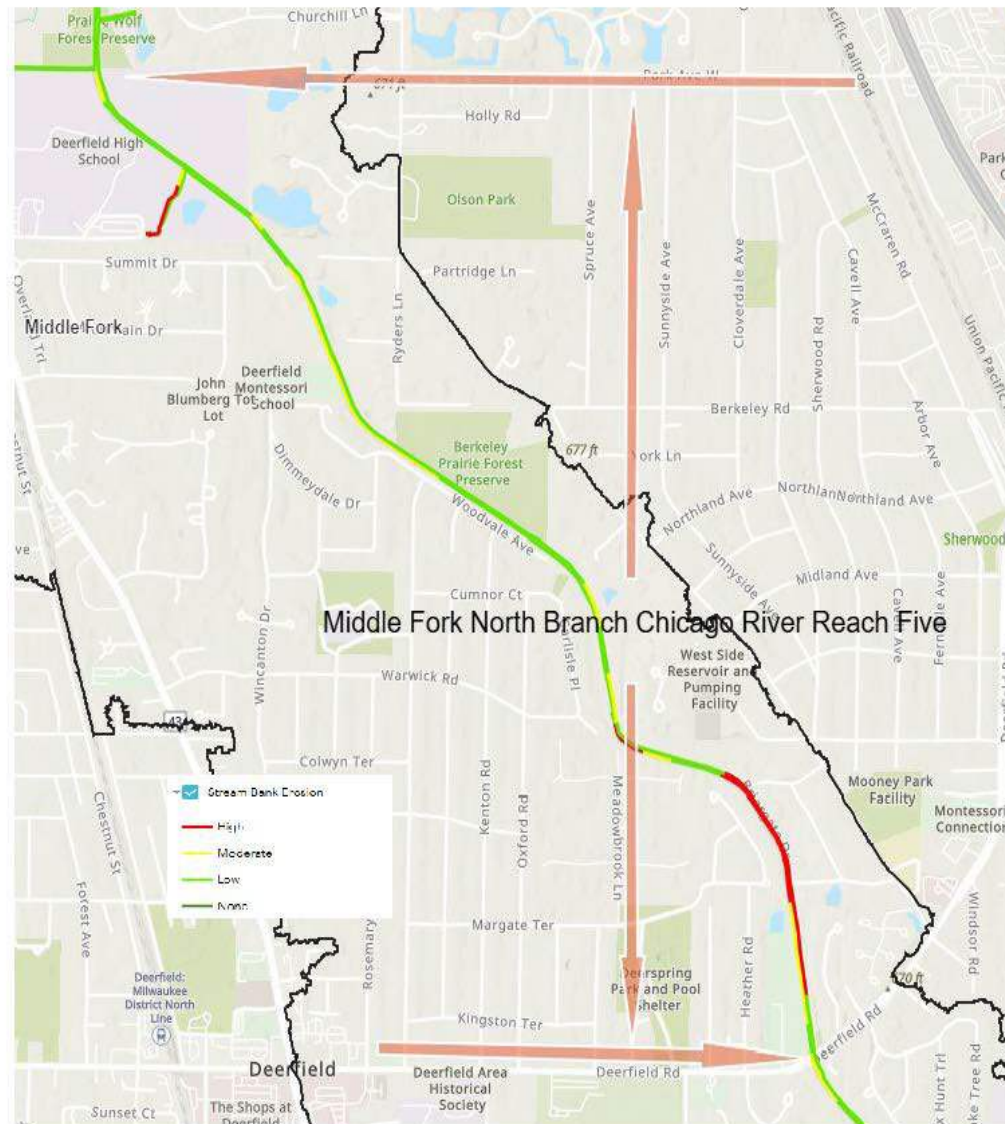
Figure 5 Middle Fork Chicago River Streambank Conditions

No new areas of bank sloughing were identified. No reaches exhibited increasing erosion relative to prior documented conditions. Of the 21,800 feet of streambank, 16% exhibit severe erosion (high), including the streambank along Briargate Drive; 22% have moderate erosion; and the remaining majority (62%) is in a low-erosion condition.

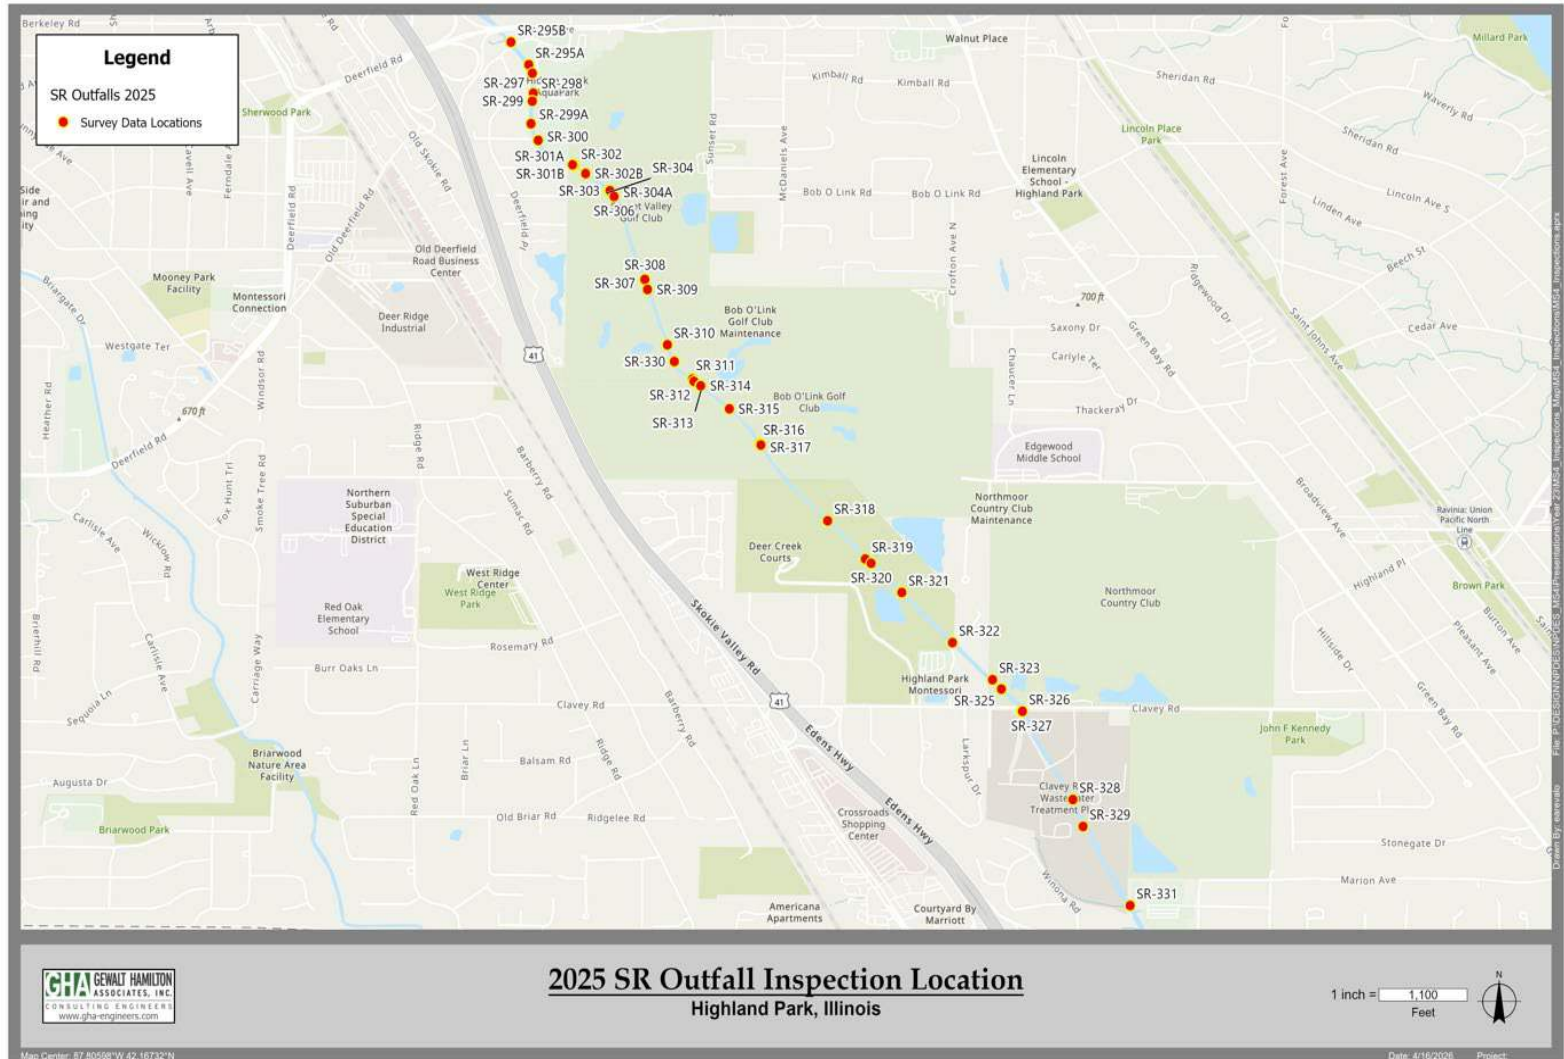
Figure 7 Skokie River Outfall Locations

Of the 78 outfalls inspected, one potential illicit discharge was identified at the outlet pipe from the Northmoor Country Club Pond #3, which discharges to the Skokie River. Upon further investigation, the discoloration of rainwater from this outlet pipe had dissipated. Based on these observations, it appeared that a chemical treatment may have been applied in the pond area, causing the discoloration. Due to the quick dissipation of the discoloration, no further action was required or taken.

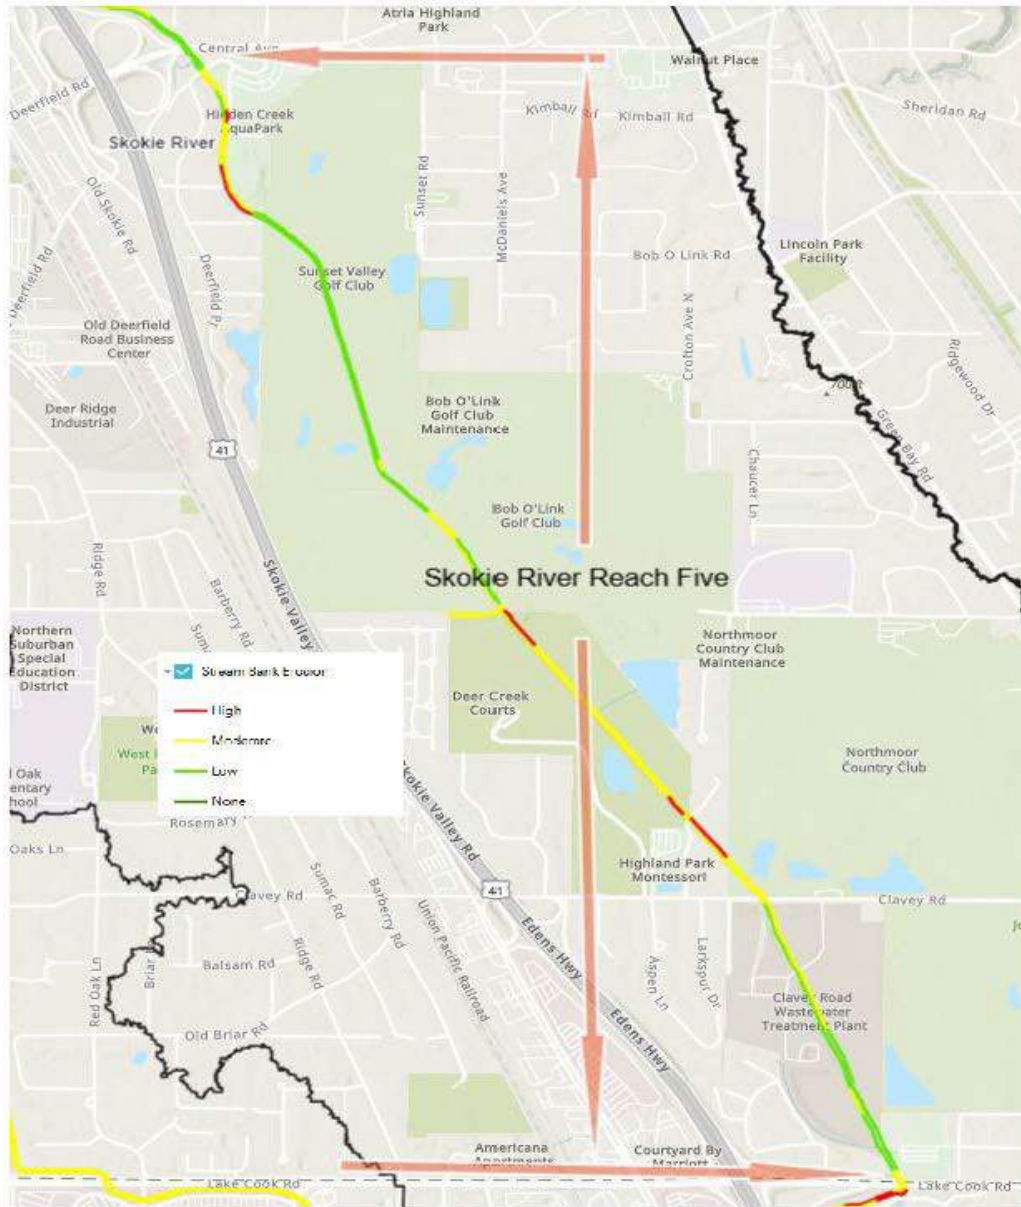
Figure 8 Middle Fork Chicago River Streambank Conditions

No new areas of bank sloughing were identified. No reaches exhibited increased erosion relative to documented conditions in 2019. 7% of the streambanks are experiencing severe erosion (high), 57% have moderate erosion, and the remaining (36%) of the streambanks are in a low erosion condition.

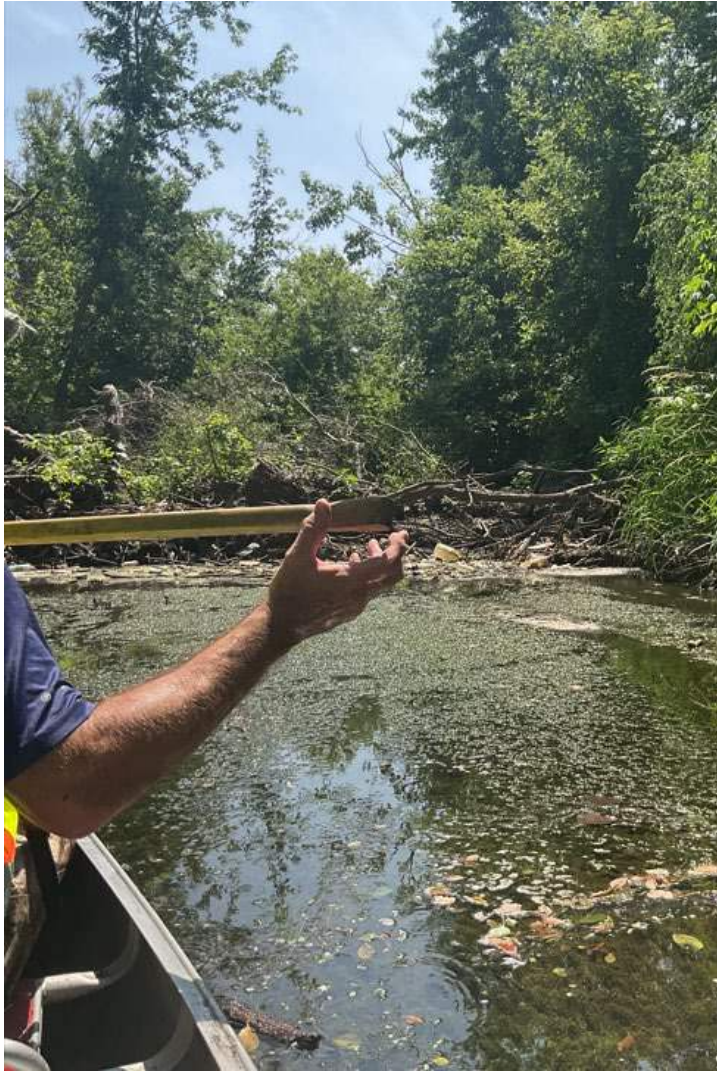
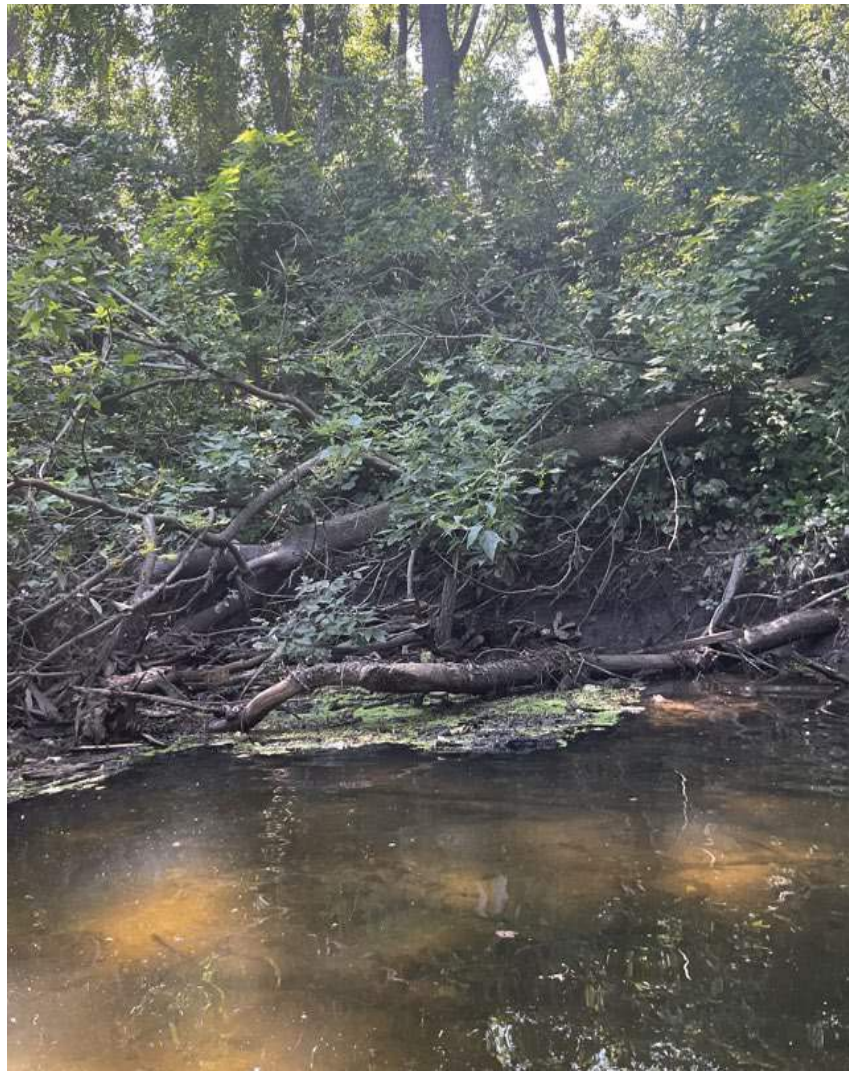
Figure 10 Skokie River Debris Jam Photos

Two large debris jams were found on the Skokie River between Clavey Road and Lake Cook Road within the North Shore Water Reclamation District property. Both jams were completely blocking the river, necessitating portaging the canoe around them. The SCDD Project Coordinator and Attorney were notified the same day. The Project Coordinator subsequently obtained quotes to remove the debris jams, authorized the contractor to proceed, and the jams have been removed. Removal of these jams may have been the most valuable outcome of the 2025 inspections.
