## Skokie Consolidated Drainage District IEPA MS4 Inspection Summary Report – Permit Year 23

Inspection Period: March 2025 – March 2026

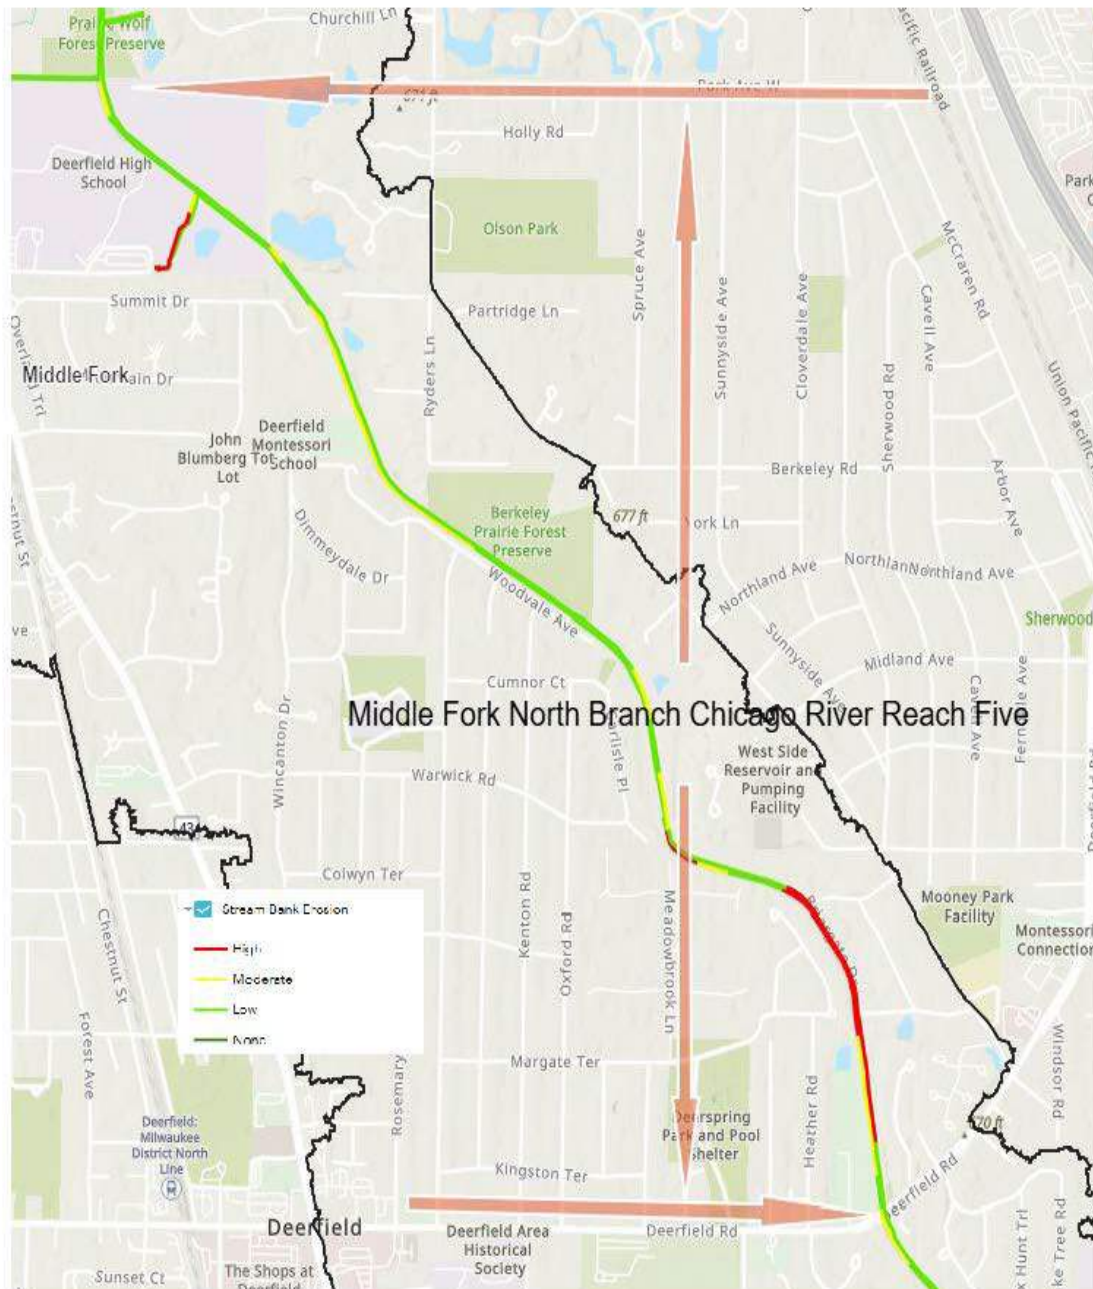
Figure 3 – MFCR Reach 5 Map and Streambank Condition

The Middle Fork Chicago River Reach 5 (See Figure 3) upstream extent is at the northern boundary of Deerfield High School property. The downstream extent is approximately 380 feet downstream of Deerfield Road. In total, it is approximately 10,900 feet (2.06 miles) in length with 38 found outfalls. This comprises about 18% of the stream length and 28% of the outfalls within the district. This reach has 21,800 feet of streambank, with 7% Forest Preserve, 16% school (DHS), 7% religious institution, and the vast majority (70%) private residential properties.

No new areas of bank sloughing were identified. No reaches exhibited increasing erosion relative to prior documented conditions. Of the 21,800 feet of streambank, 16% exhibit severe erosion (high), including the streambank along Briargate Drive; 22% have moderate erosion; and the remaining majority (62%) is in a low-erosion condition.

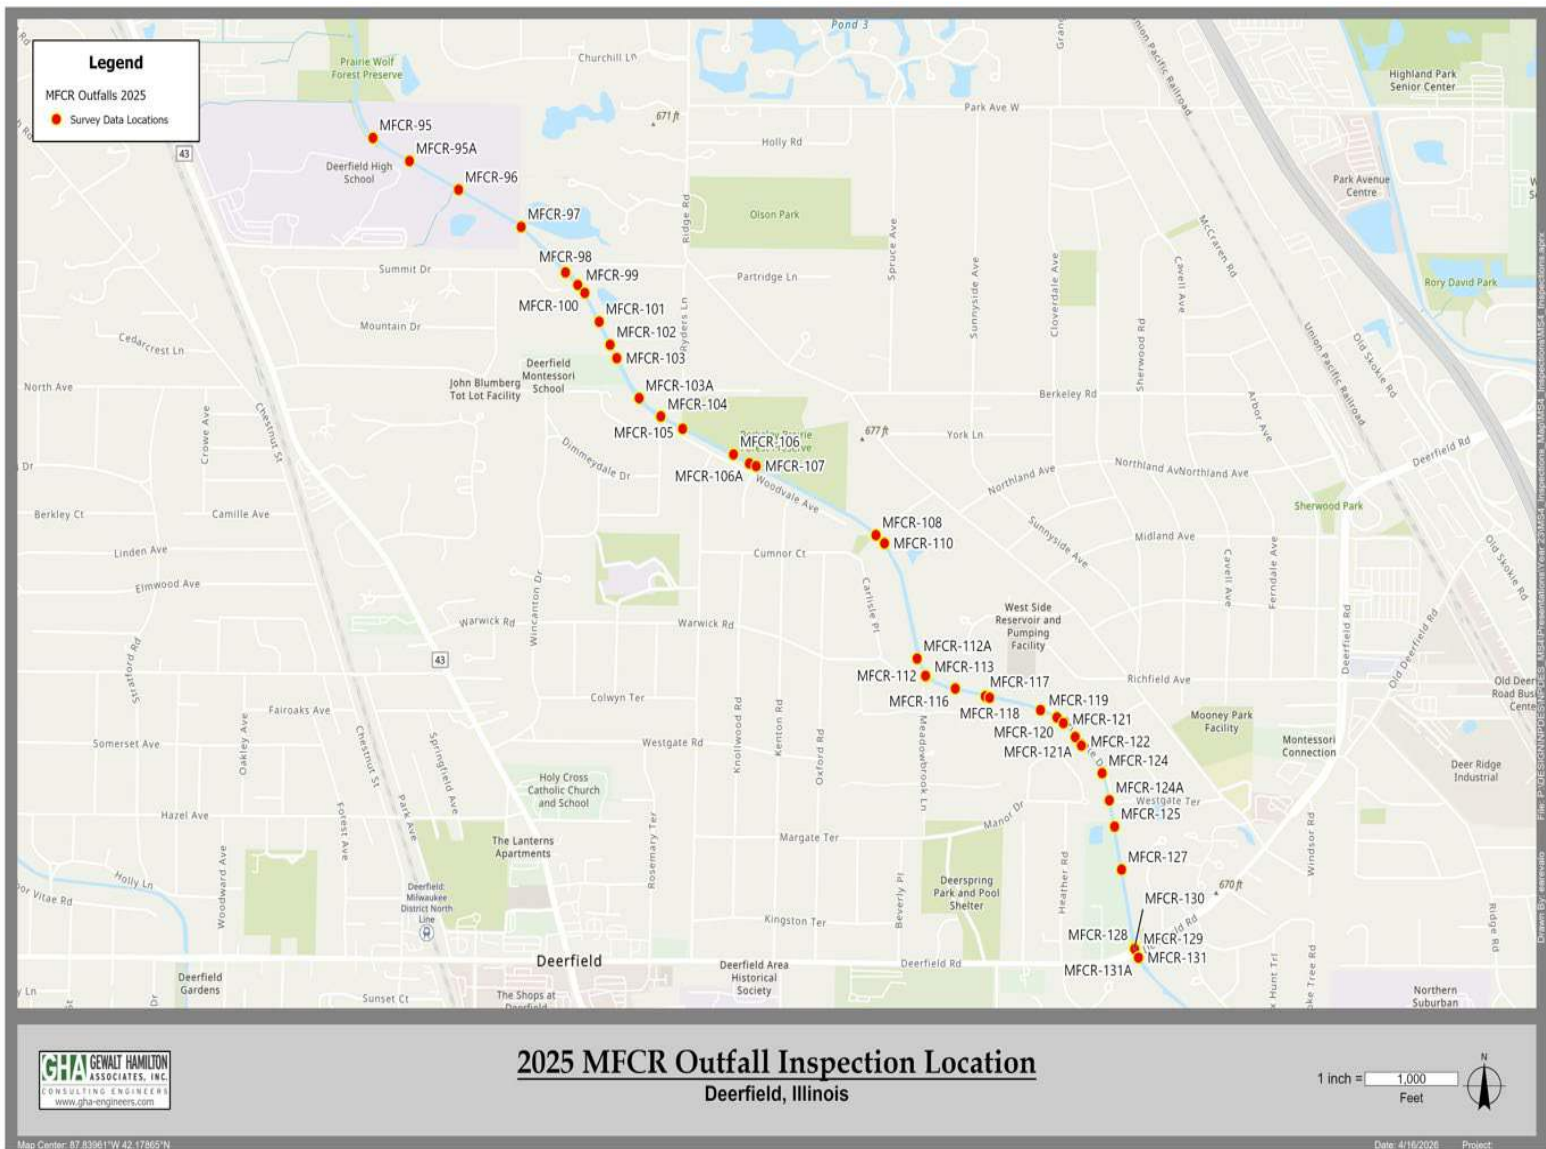
Figure 4 Middle Fork Chicago River Outfall Locations

38 outfalls were inspected (See Figure 4 below). Many outfalls appeared to be abandoned, as noted on the inspection forms. These were all on private properties. The MFCR outfall reports can be found here: [MFCR Outfalls](#)

No illicit discharges were found on the Middle Fork North Branch Chicago River

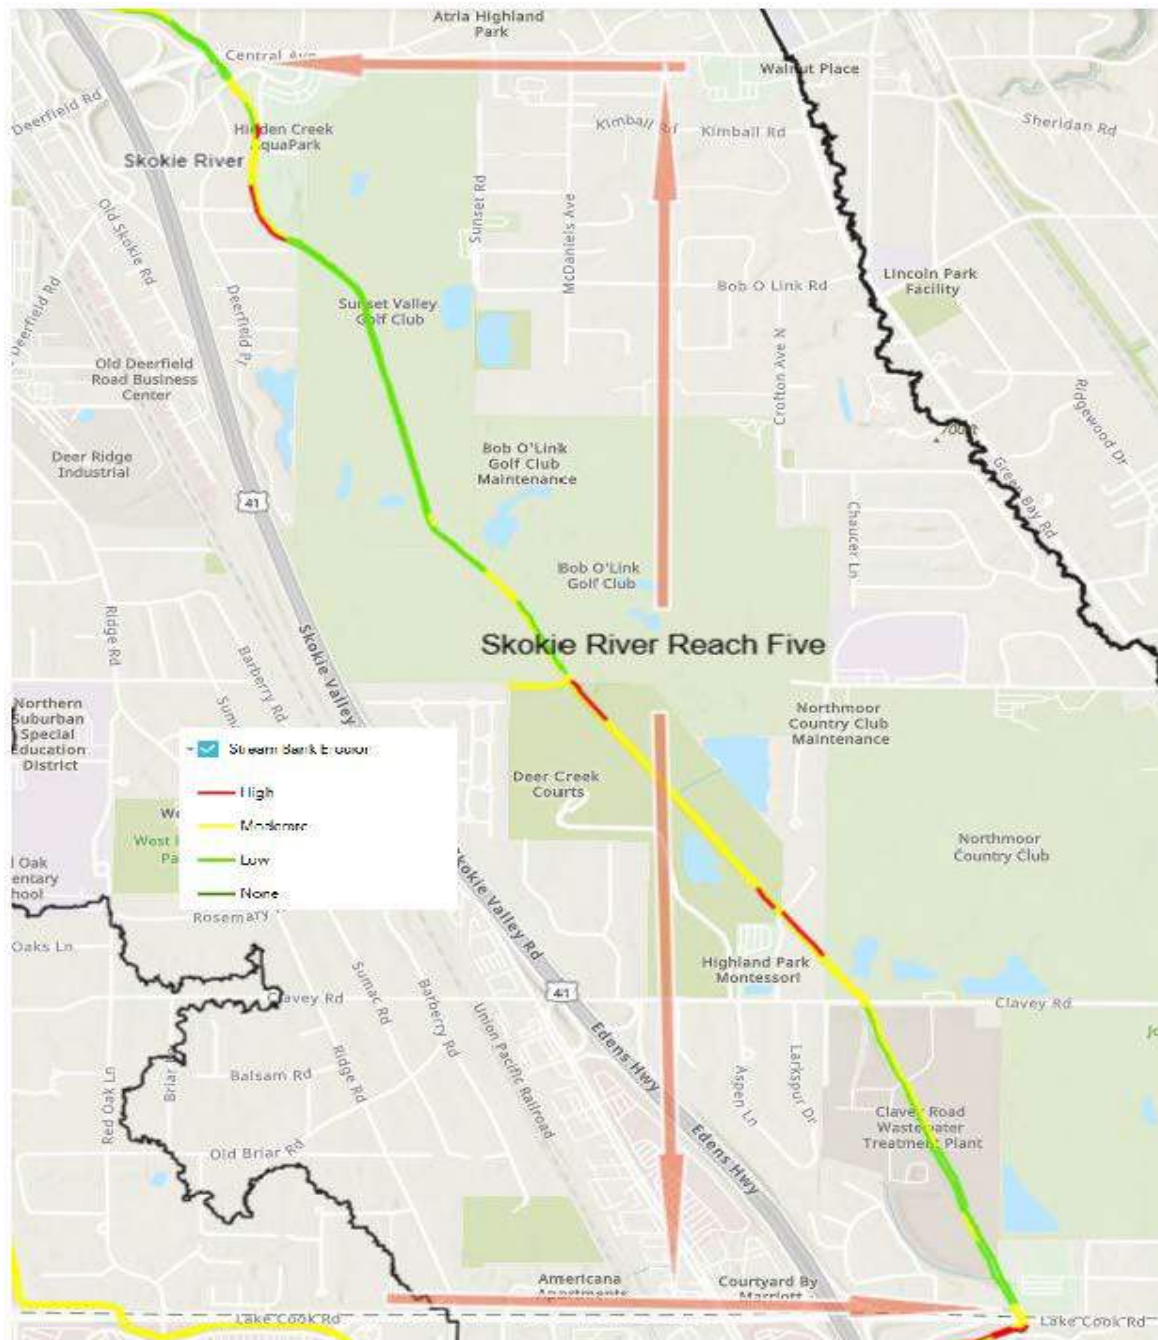
Figure 6 Skokie River Reach 5

The Skokie River Reach 5 upstream extent is at Fredrickson Place just south of Central Avenue in Highland Park. The downstream extent is the upstream side of Lake-Cook Road near the Chicago Botanic Gardens. In total, it is approximately 12,100 feet (2.3 miles) in length with 40 found outfalls. This comprises about 18% of the stream length and 13% of the outfalls within the district. This reach has 24,200 feet of streambank, with 7% private golf courses (Bob O'Link/Northmoor), 21% Government (NSWRD), and comprising half of this (50%) is park district (PDHP), and the remaining amount (22%) is private residential properties.

No new areas of bank sloughing were identified. No reaches exhibited increased erosion relative to documented conditions in 2019. 7% of the streambanks are experiencing severe erosion (high), 57% have moderate erosion, and the remaining (36%) of the streambanks are in a low erosion condition.

Two large debris jams were found on the Skokie River between Clavey Road and Lake Cook Road within the North Shore Water Reclamation District property. Both jams were completely blocking the river, necessitating portaging the canoe around them. The SCDD Project Coordinator and Attorney were notified the same day. The Project Coordinator subsequently obtained quotes to remove the debris jams, authorized the contractor to proceed, and the jams have been removed. Removal of these jams may have been the most valuable outcome of the 2025 inspections.
